# **Cedar Lake Rehabiliation Project**

Winterset Municipal Utilities
Winterset, Iowa
Madison County

#### The Cedar Lake Rehabilitation Project

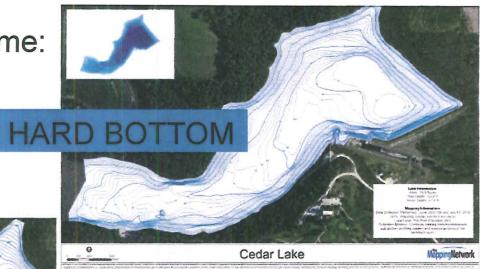
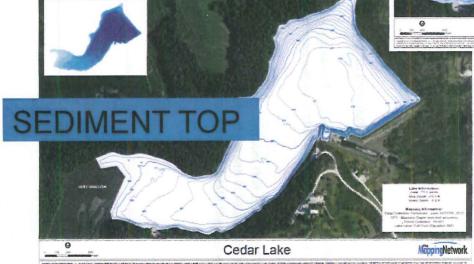
Sediment volume:

• 1,099,000 CY

## Potential water volume:

- 2,264,000 CY
- 457,313,000 gal
